Technical Notes

My Ethanol Story

By Steve Pargeter

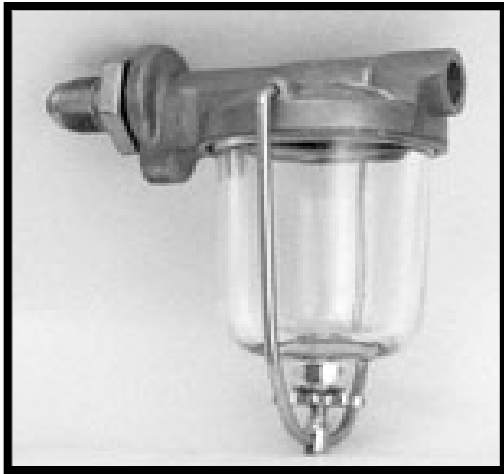
I recently replaced the sediment bowl in my Model A with a new one made by Vintique. The new unit looked great and came with a neoprene gasket and a copper screen. Neoprene is a synthetic rubber and is common today in gas lines and gaskets. Prior to the 10% ethanol mixture in gasoline I had no problems with neoprene gaskets but that has changed with today's fuel mix. Shortly after I replaced the sediment bowl I saw a layer of what looked like a gel forming inside the bowl. The strange layer looks like a jelly with bits of black arrayed across it. When you remove the sediment bowl to clean it, the jelly layer disappears on the ground but is clearly seen in the sediment bowl.

When I removed the glass sediment bowl the neoprene gasket quickly expanded about 25% larger than it had been and it could not be placed back. Needless to say this is a real problem since you cannot drive the car with the sediment bowl off. I was lucky that one of the Model A club members was with me at the time and we went to his house and found another gasket which allowed me to get home. After about three days the swollen gasket returned to its original shape and size, ready to trick the next sucker who uses it. I contacted the supplier of the bowl and was told the rest of his stock had a composition cork gasket in place of the neoprene gasket. It appears Vintique has heard of this problem and made a running change. I contacted MAFCA's Technical Director to see if others had experienced a similar problem. From the replies to my inquiry I learned many others are having similar problems with neoprene gaskets and fuel hoses swelling and deteriorating. One reply came from a chemist who said the black specks and gel I saw were parts of the gasket and the jelly layer was caused by the reaction of ethanol and neoprene.

Now that I think I know what was causing the jelly layer in my sediment bowl, I changed the gasket from neoprene to composition cork gasket material. This is not straight cork but a manufactured gasket material with a dark background imbedded in the cork. I found this gasket material at the local NAPA store. I am also going to try a gasket made of leather since I believe it might provide long term protection to the ethanol. Since I changed gasket material I have not seen any more jelly layers so it appears the gasket was causing the problem.
