### Technical Tip “Engine Knock”

By Lynn Sondenaa

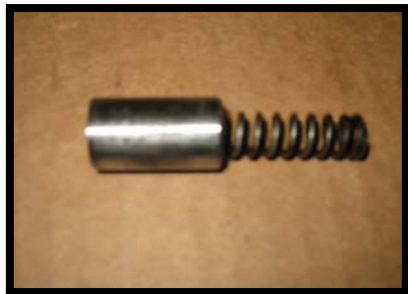
Fig 1

First, the camshaft thrust plunger (A-6275) and spring (A-6276) should be replaced with new American made units (*Fig. 1*). These need to be well lubricated when assembled. Old units can have wear and weak springs. The original units are hard to test, due to the lack of specifications. A weak spring or worn plunger allows the camshaft to move back and forth making an engine knocking noise. This noise can be mistaken for rod or main bearing knock. (*Fig. 2*). A side note is that the movement of the camshaft will cause wear on the oil pump/distributor drive gear (A-6551).

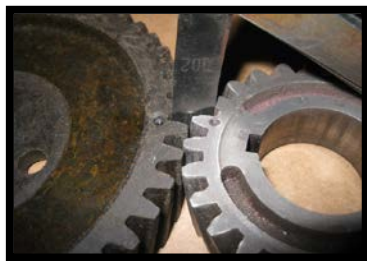
Fig 3

Second, check the backlash between the timing gear and the crankshaft gear. This is measured with a feeler gauge and should read between .003" and .005" (*Fig. 3*). If you are getting excessive backlash you can use an oversized gear, either .003" or .005".

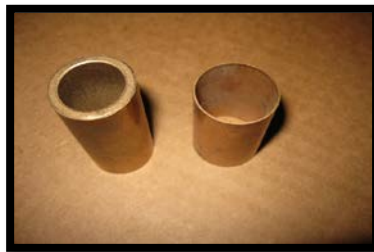
Fig 4

Fourth, the camshaft center journal with the drive gear should have a diameter of 1.557" or larger, with no pits and good teeth along with no wear. Excessive wear on teeth or incorrect tolerances will cause a knock between the camshaft and oil pump/distributor drive gear, or the camshaft and block. The fix can be so-so (cheap) or very expensive. The cheap fix is to purchase an oversized oil pump/distributor drive gear in either .004" or .010". The teeth are wider to compensate for the camshaft wear. The expensive fix is to purchase a new camshaft and maybe have the block machined for camshaft journal sleeves (bushings). (*Fig. 4*).
