A Pre-Check before Adjusting the Model A Brakes

By Lynn Sondena = Sandy, Oregon

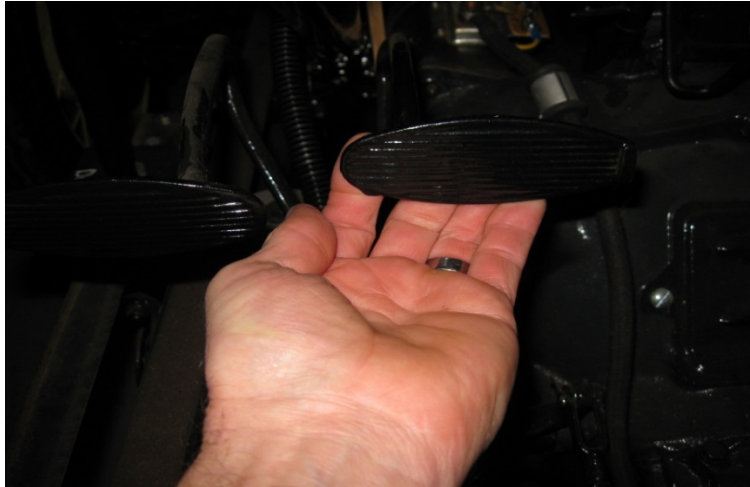
Fig.1

- Unhook and remove all service brake rods and emergency brake rods.
- Grab the brake pedal to check for side way movement. (Fig.1) If the pedal moves, then replace the pedal shaft bushings.

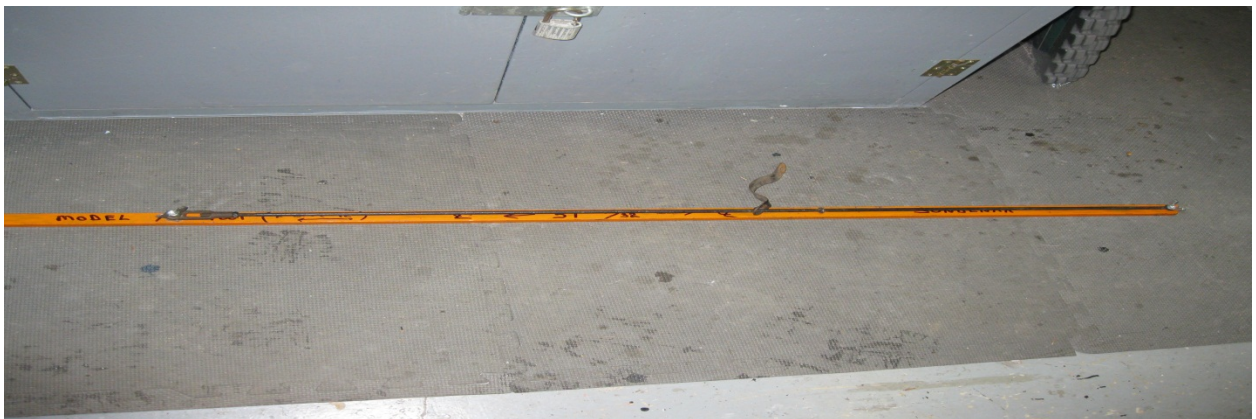
Fig.2a

- Set the length of the service brake rods to 51 15/32 on an inch. Set the emergency brake rods to 42 inches. I use a homemade fixture for this purpose. Figure 2a shows the fixture in use on an emergency brake rod, while figure 2b shows a close up of the fixture. These measurements are from center to center of the eye holes. Also check to be sure there is no play in brake rod pins A-2462. If there is play there are two choices for repair. Either drill the holes oversized to .340 (11/32), or weld, grind, and re-drill to the original size of .310 (5/16).

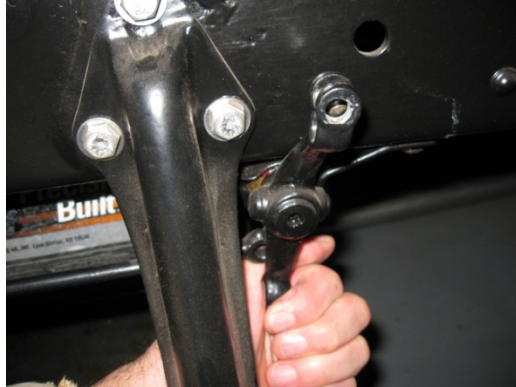
Fig.4

- Do the same test as above on the rear brake levers A-2235.
- Grab the cross shaft and check to see if it moves up and down. (Fig. 4) If it moves then the cross shaft bushings should be replaced.

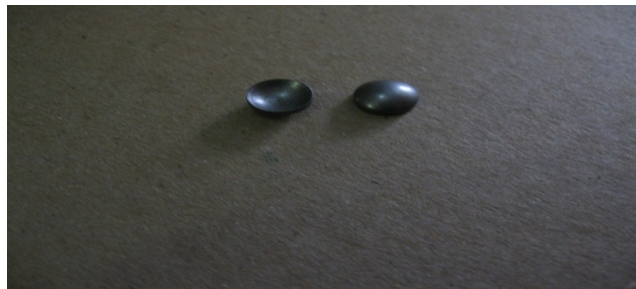
Fig.5

I would recommend that if you have found worn parts on the above test, the front brake operating pins A-2075 be checked for length and straightness. These parts tend to wear with time and become short. Shims or pills are available (A-2075-SH or A-2052-S) to take up the slack. (Fig.5). The original length of these pins were 7.250 inches ($7 \frac{1}{4}$). I have found that if the operating pins are bent, it is due for two reasons. First, the pins were bent due to incorrect assembly or disassembly. Hammers and excessive force were being used. Second, check to see if there are multiple shims or pills in the brake wedge. Too many shims can cause the operating pin to be too long and bend.

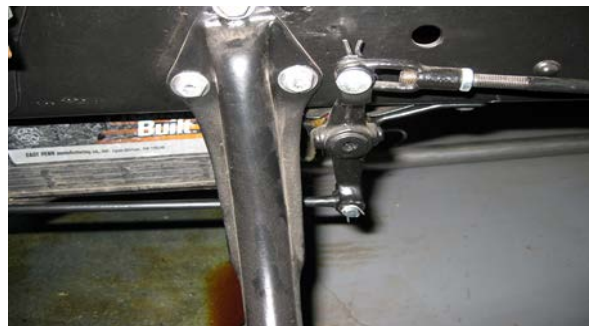
Fig.6

Reattach all of the brake rods, making sure the cross shaft is in a vertical position (Fig.6). The connecting rod from the brake pedal to the cross shaft A-2465 should be adjusted to hold the brake pedal at the top step on the bell housing. The brakes are now ready to be adjusted.
